Legacy Sediment Removal and the Big Spring Run Restoration Project

Cost-Effective Aquatic Ecosystem Restoration

Pennsylvania
Department of Environmental Protection

Big Spring Run Legacy Sediment Removal and Aquatic Ecosystem Restoration Project

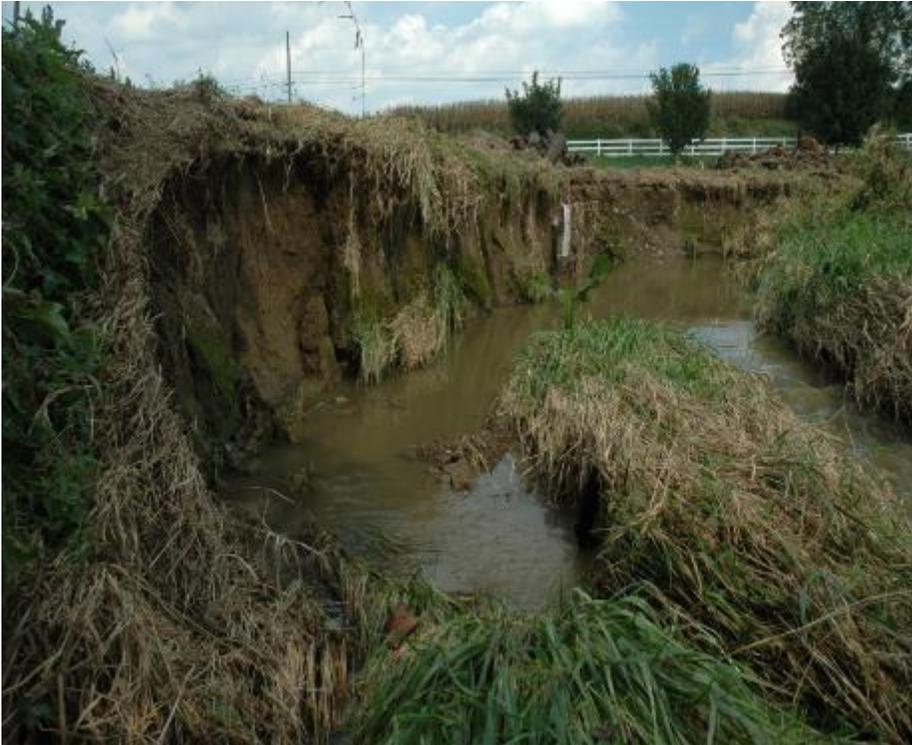
Typical Existing Conditions

9/13/2011

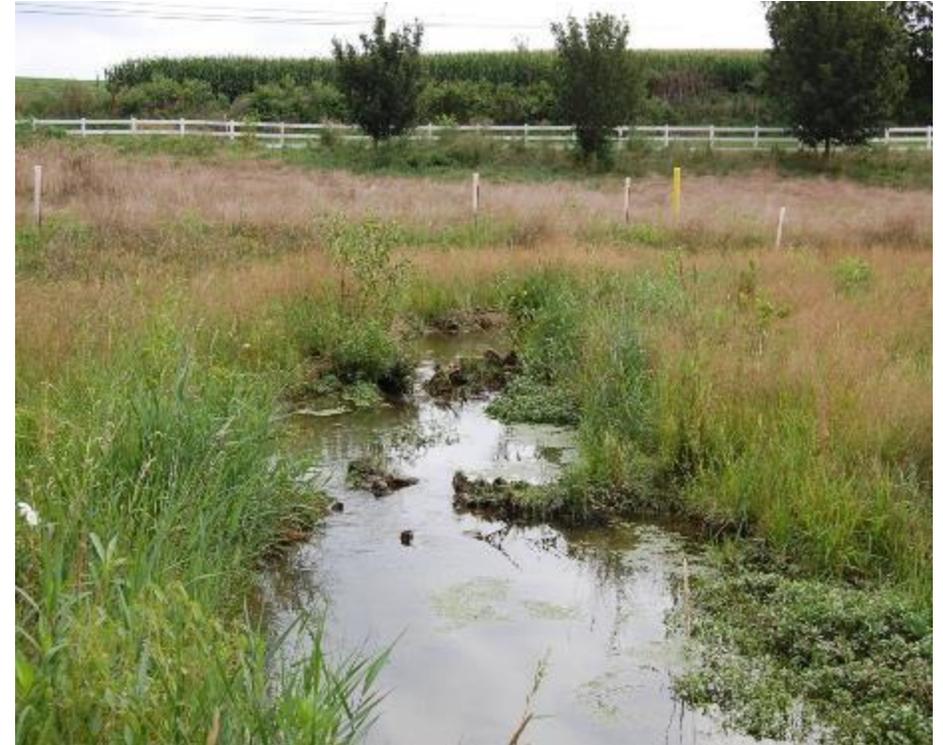
Restoration

07/27/2012

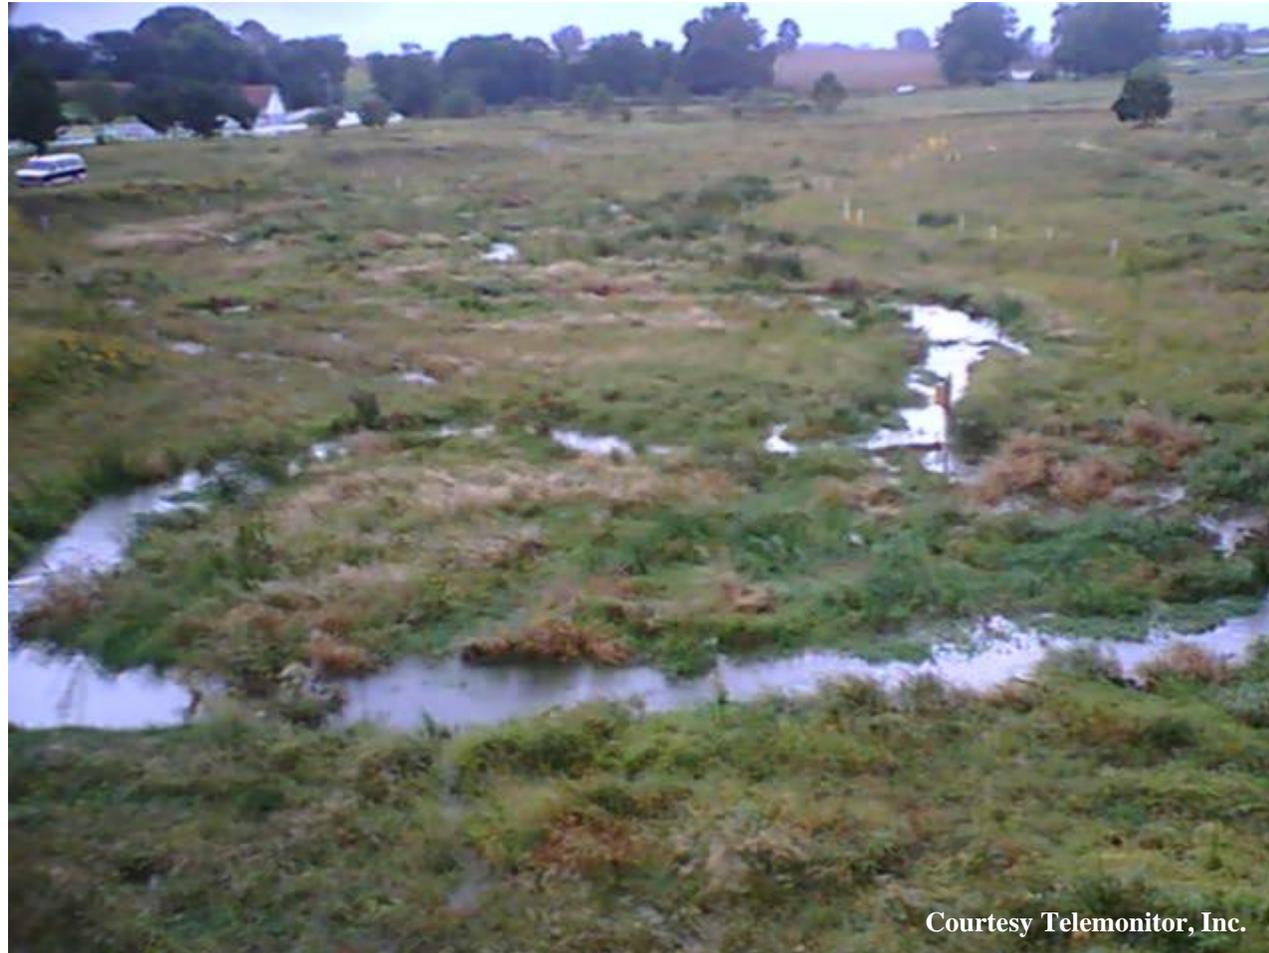
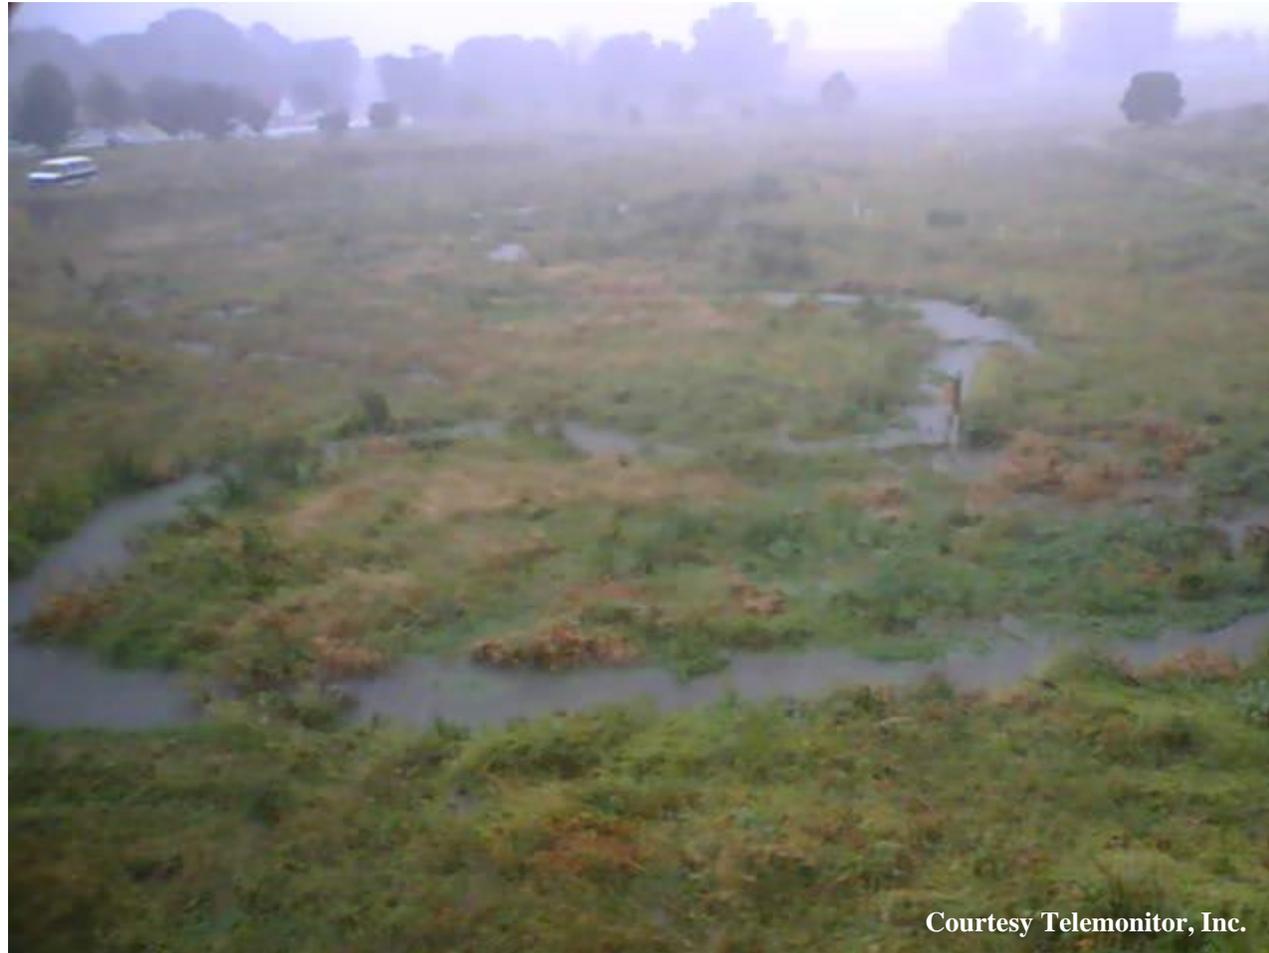
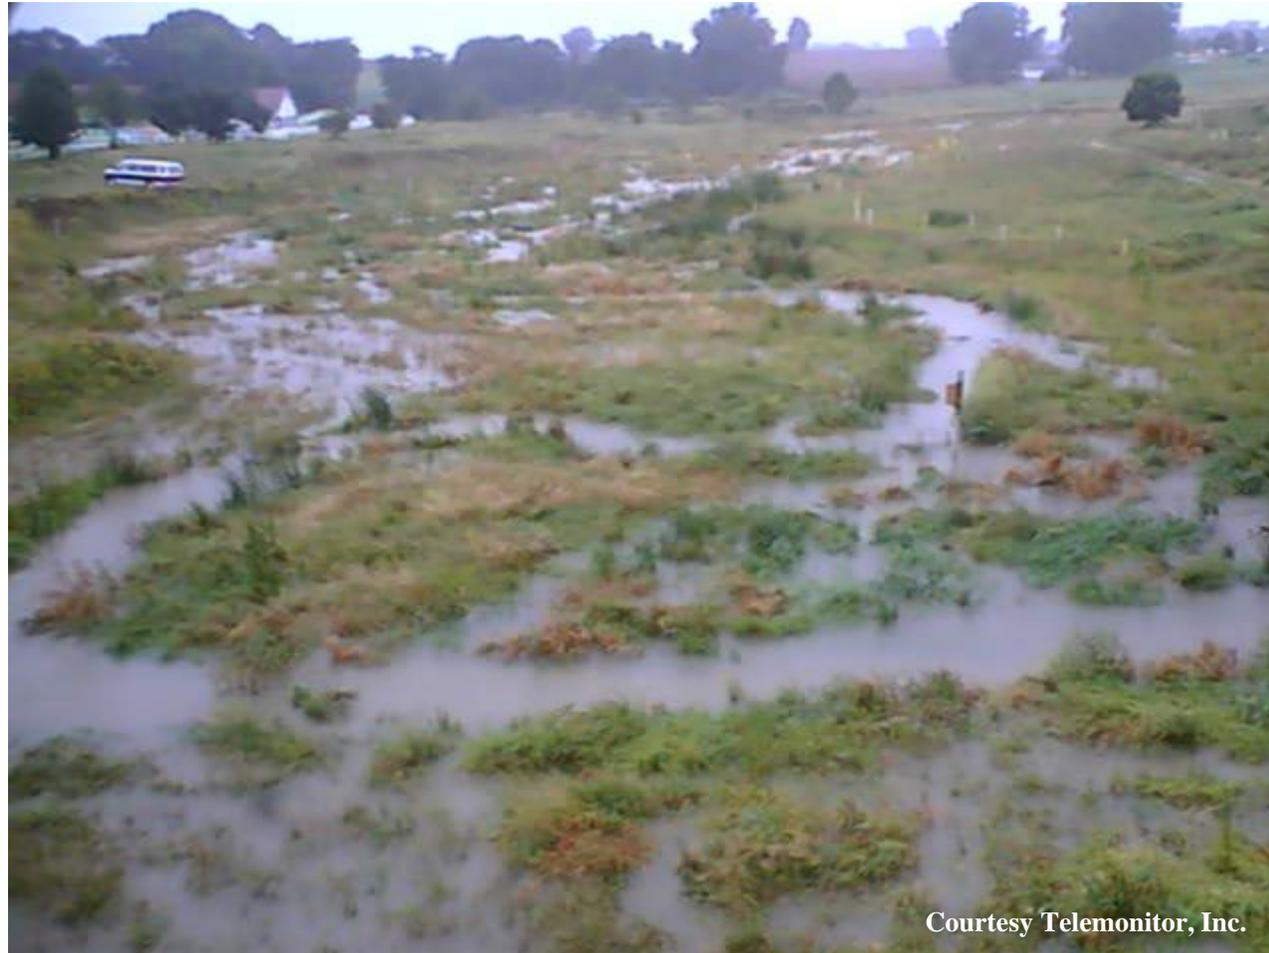
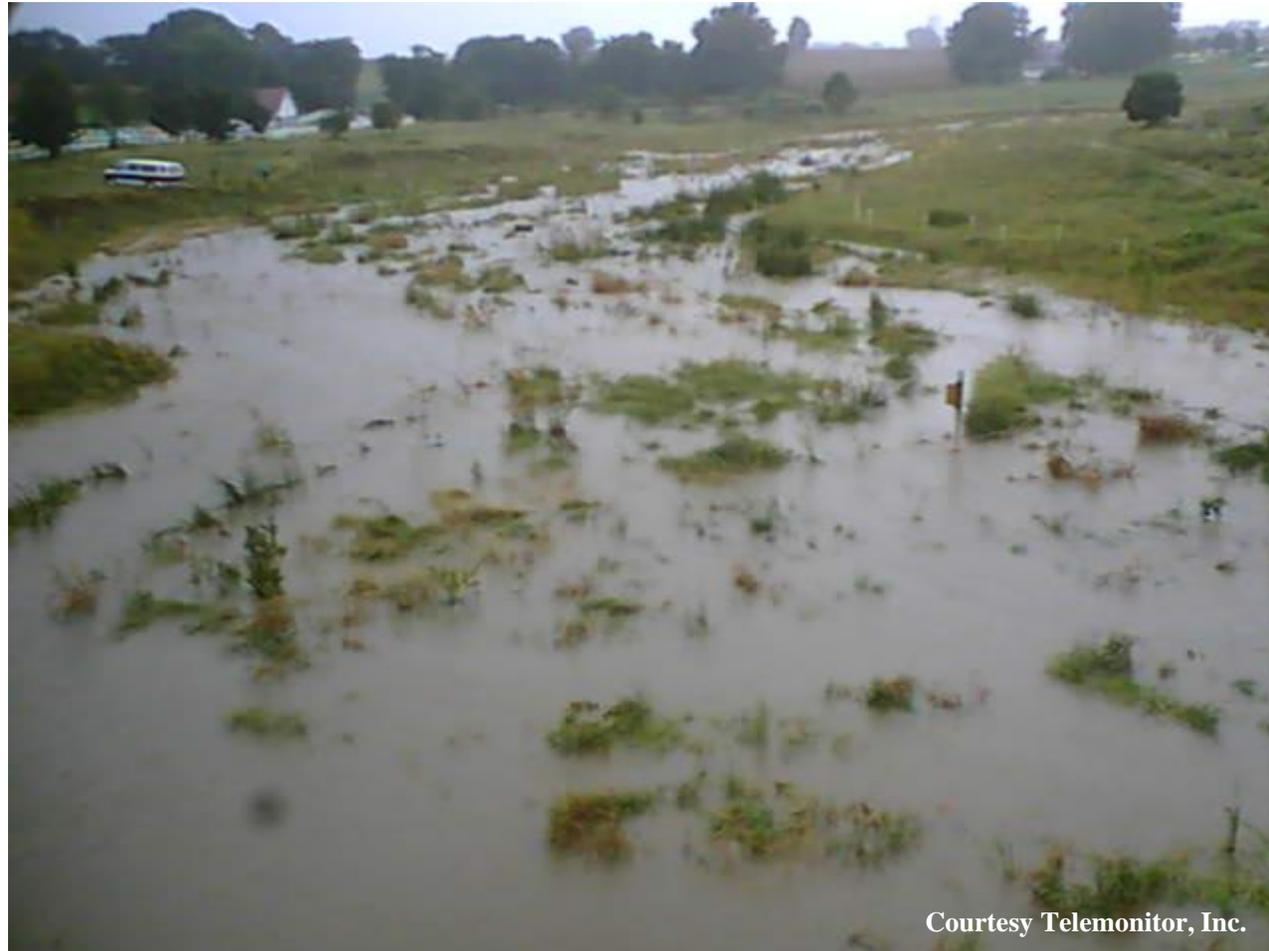
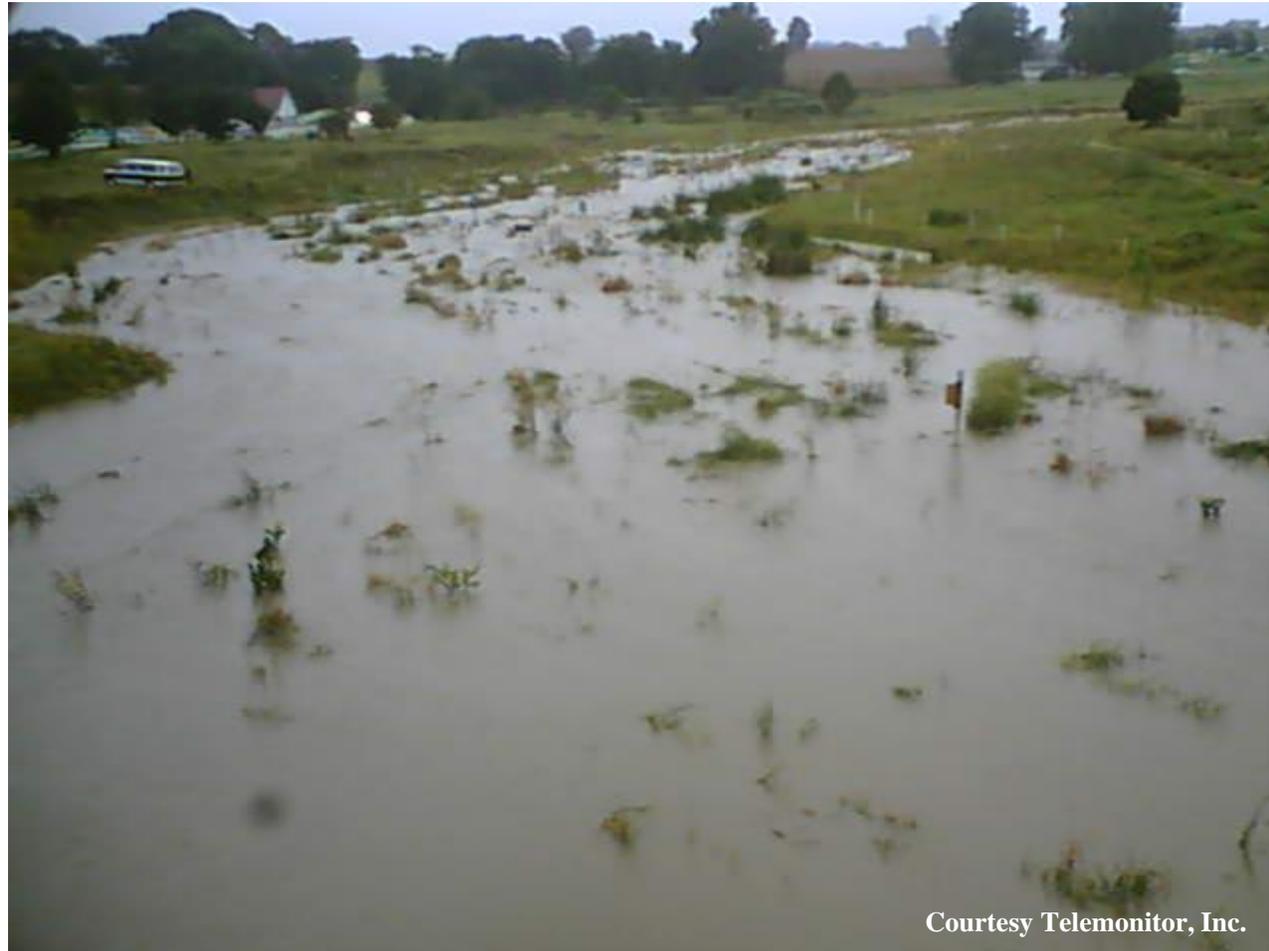
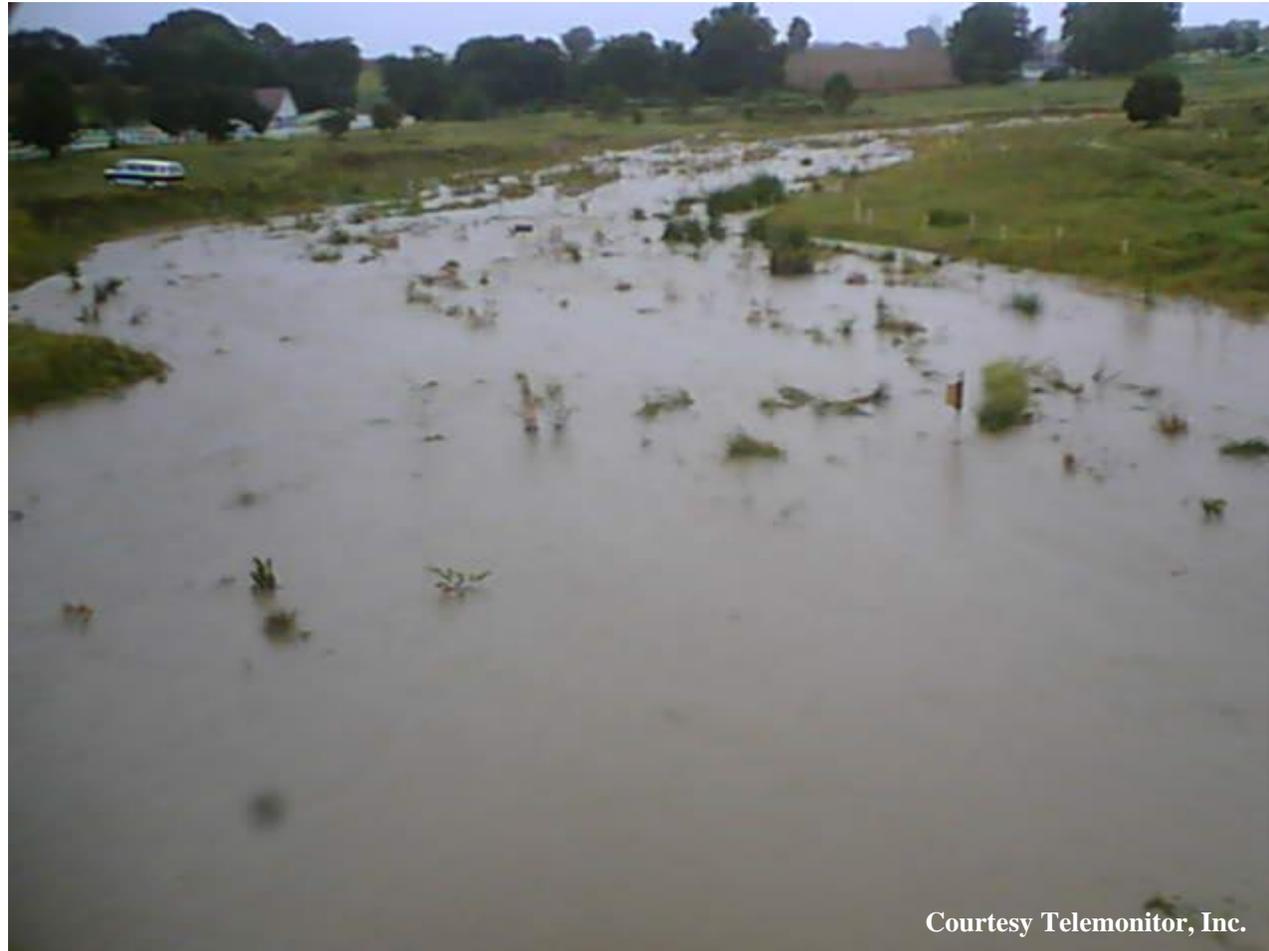
Big Spring Run post-restoration storm

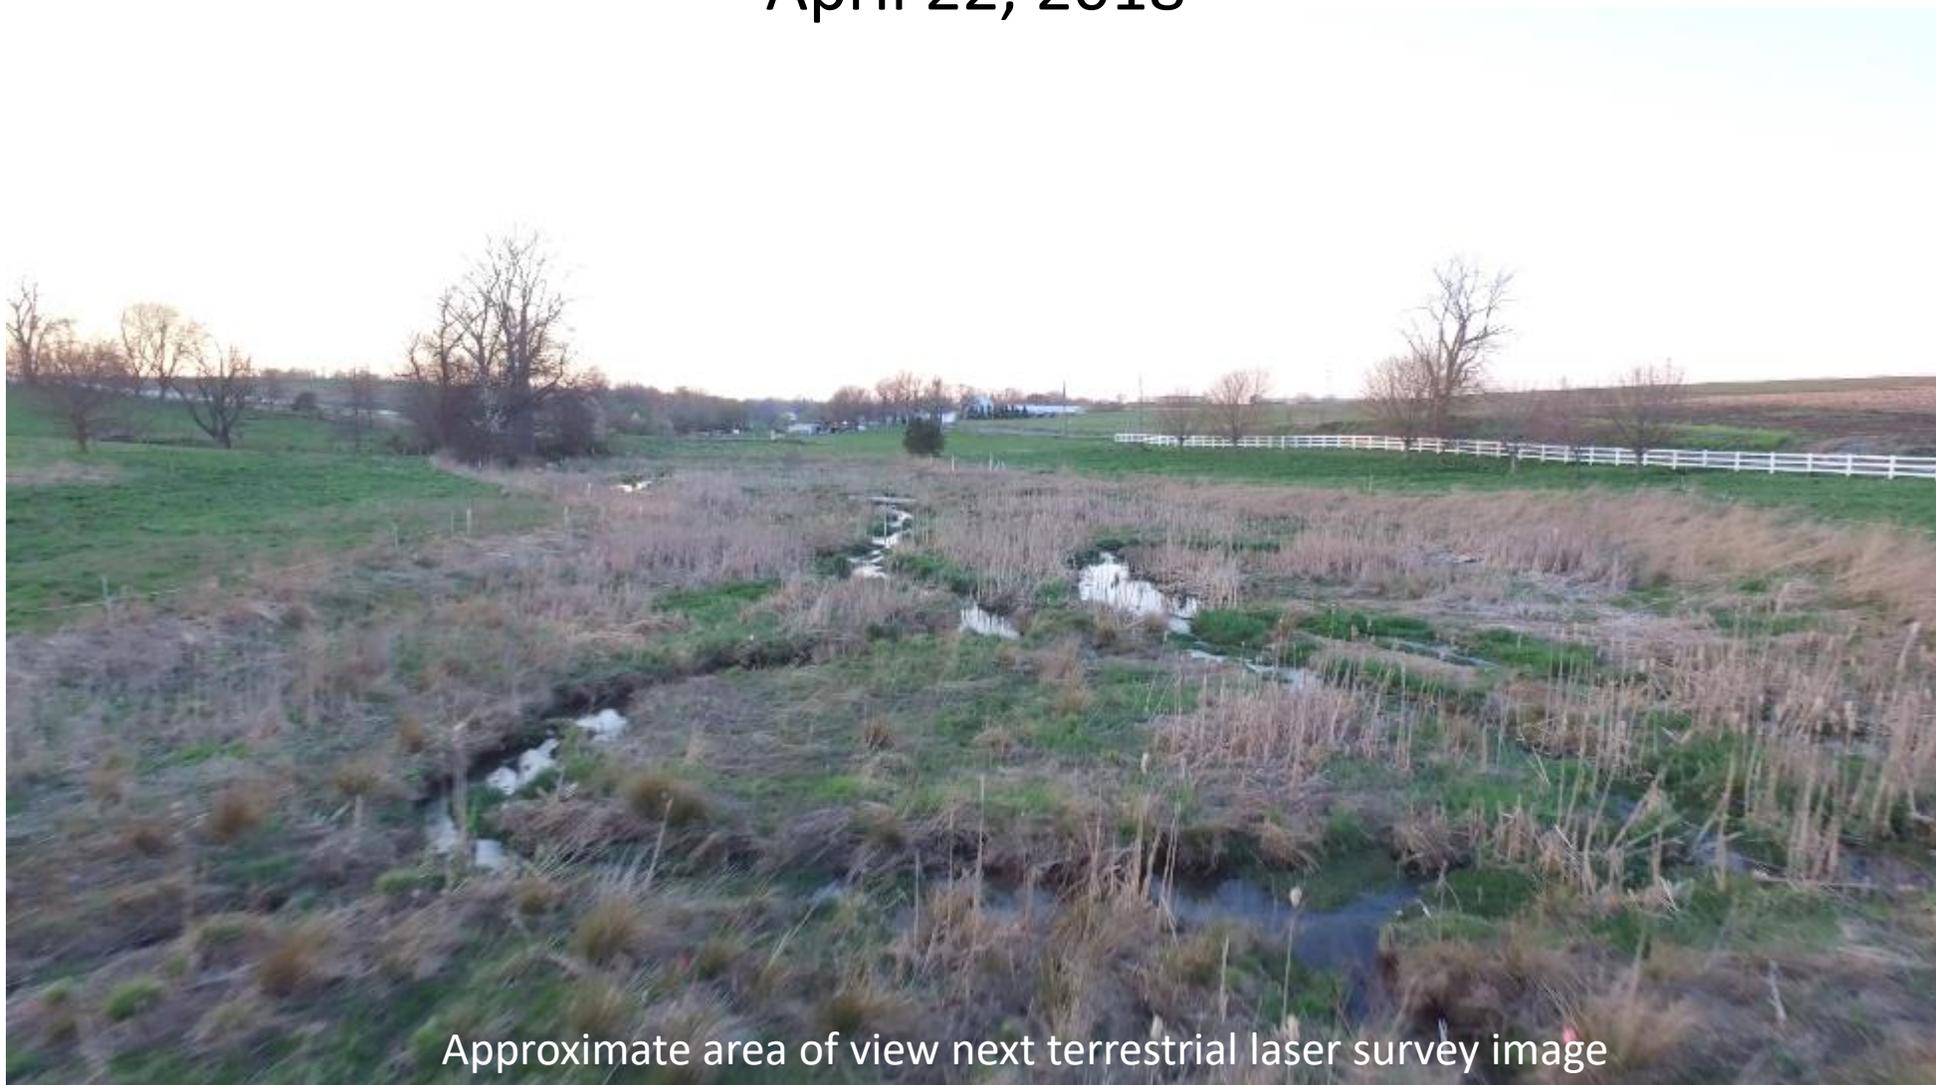
Post-restoration UAV (drone) image of anastomosing channel form April 22, 2018

Approximate area of view next terrestrial laser survey image

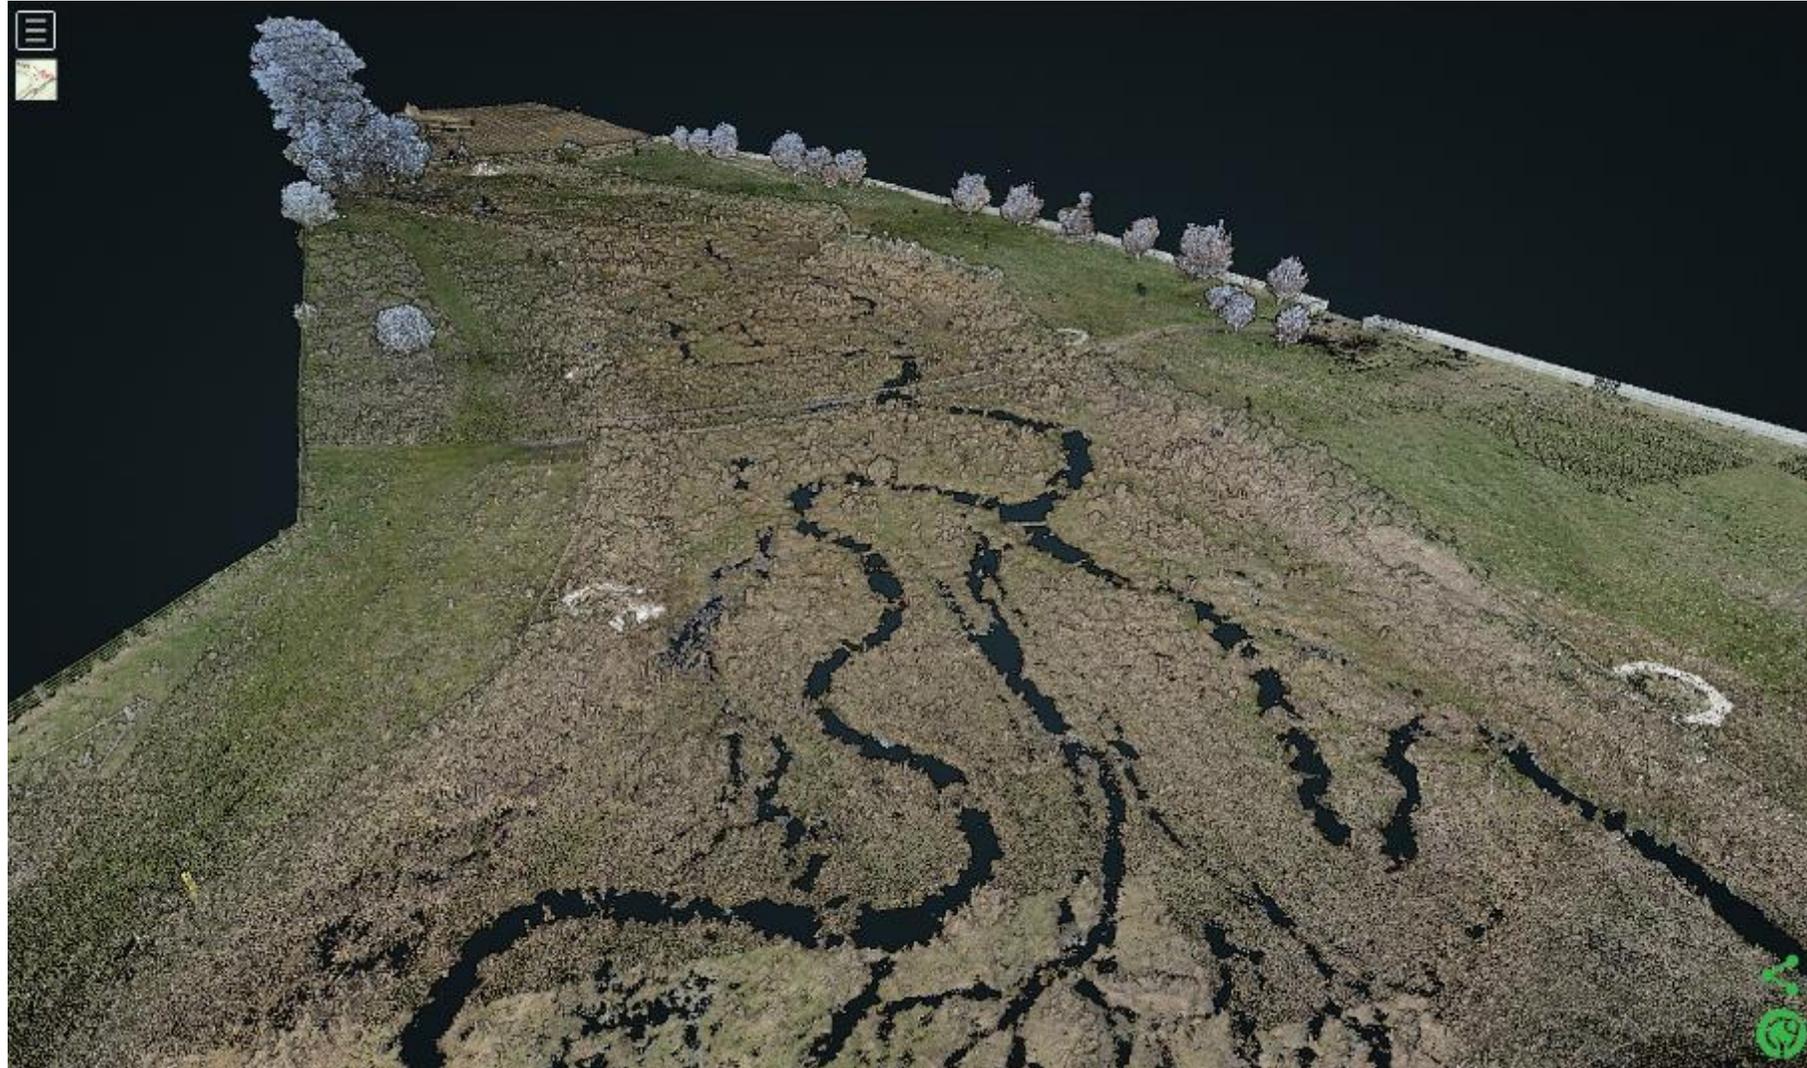
Post-restoration terrestrial laser survey

April 11, 2014

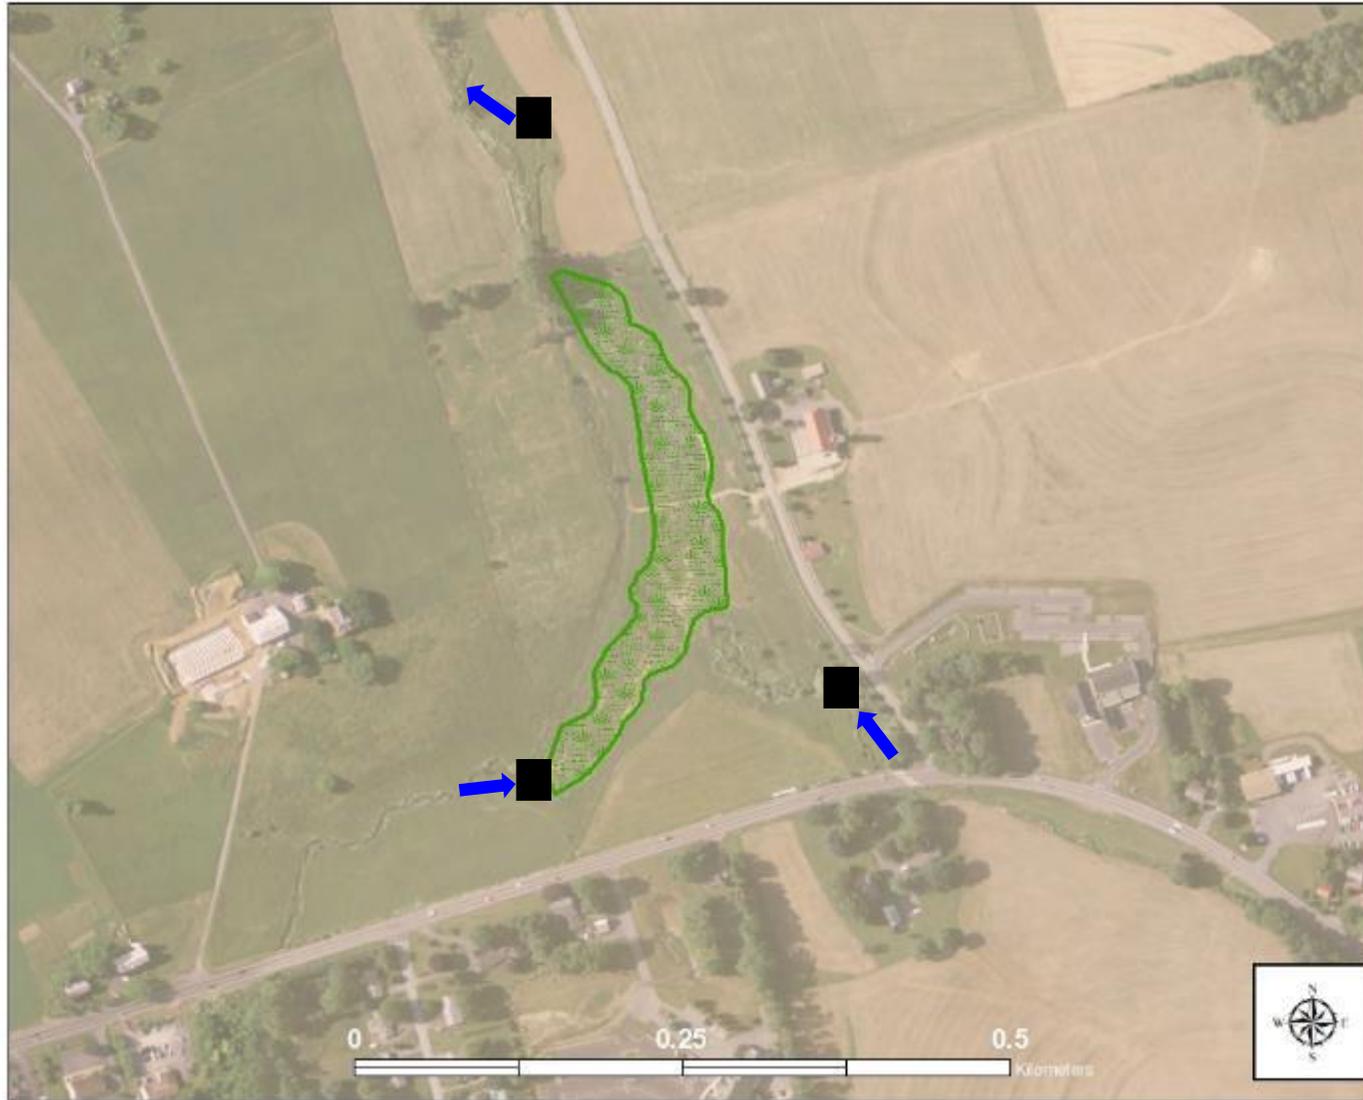
USGS Sample Sites

■ Stream gage locations → Flow direction
