Monitoring Ecological Change and Project Effectiveness: Examples from San Antonio Creek, Jemez Mountains, NM

Karen Menetrey, Rio Grande Return
Tribal Clean Water Act Training
Isleta Resort
March 4-7, 2024

San Antonio Creek Beaver Habitat and Water Quality Project

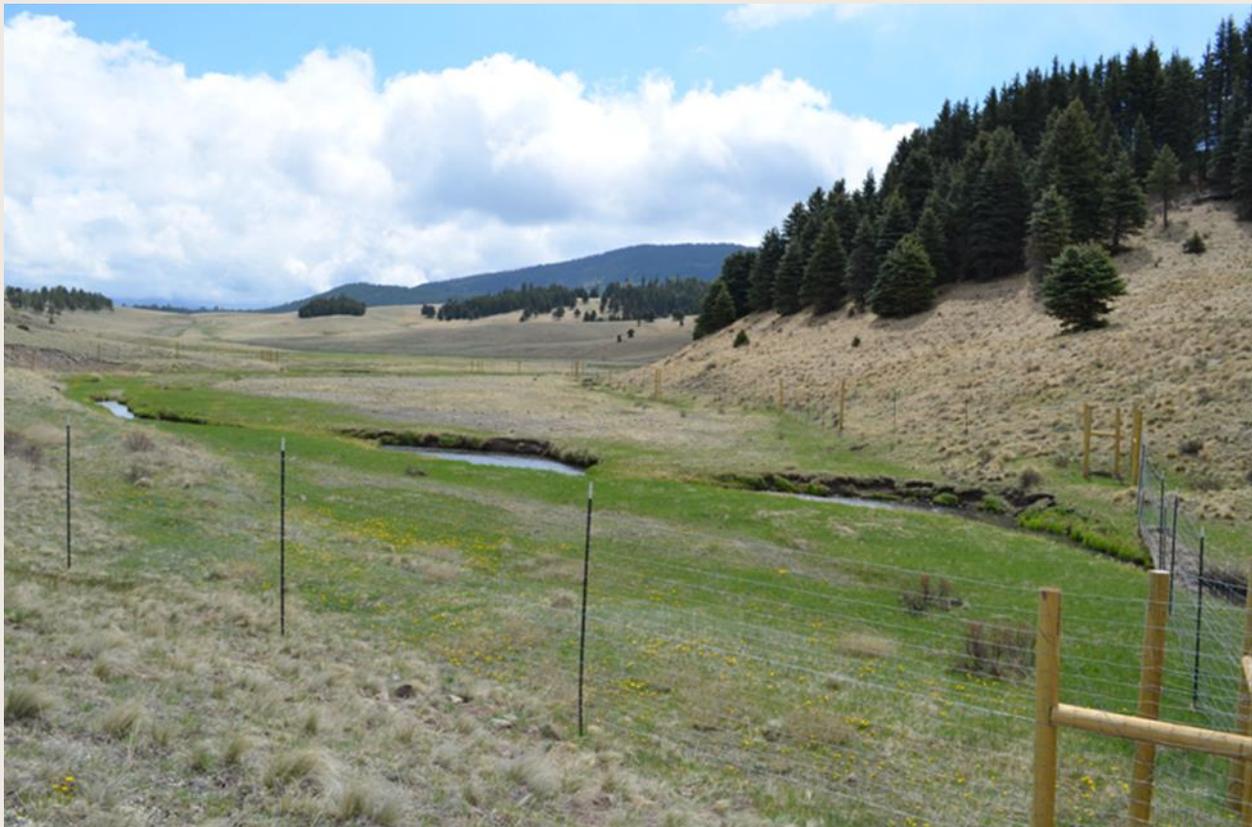
July 2012

San Antonio Creek Before/After Project Characteristics

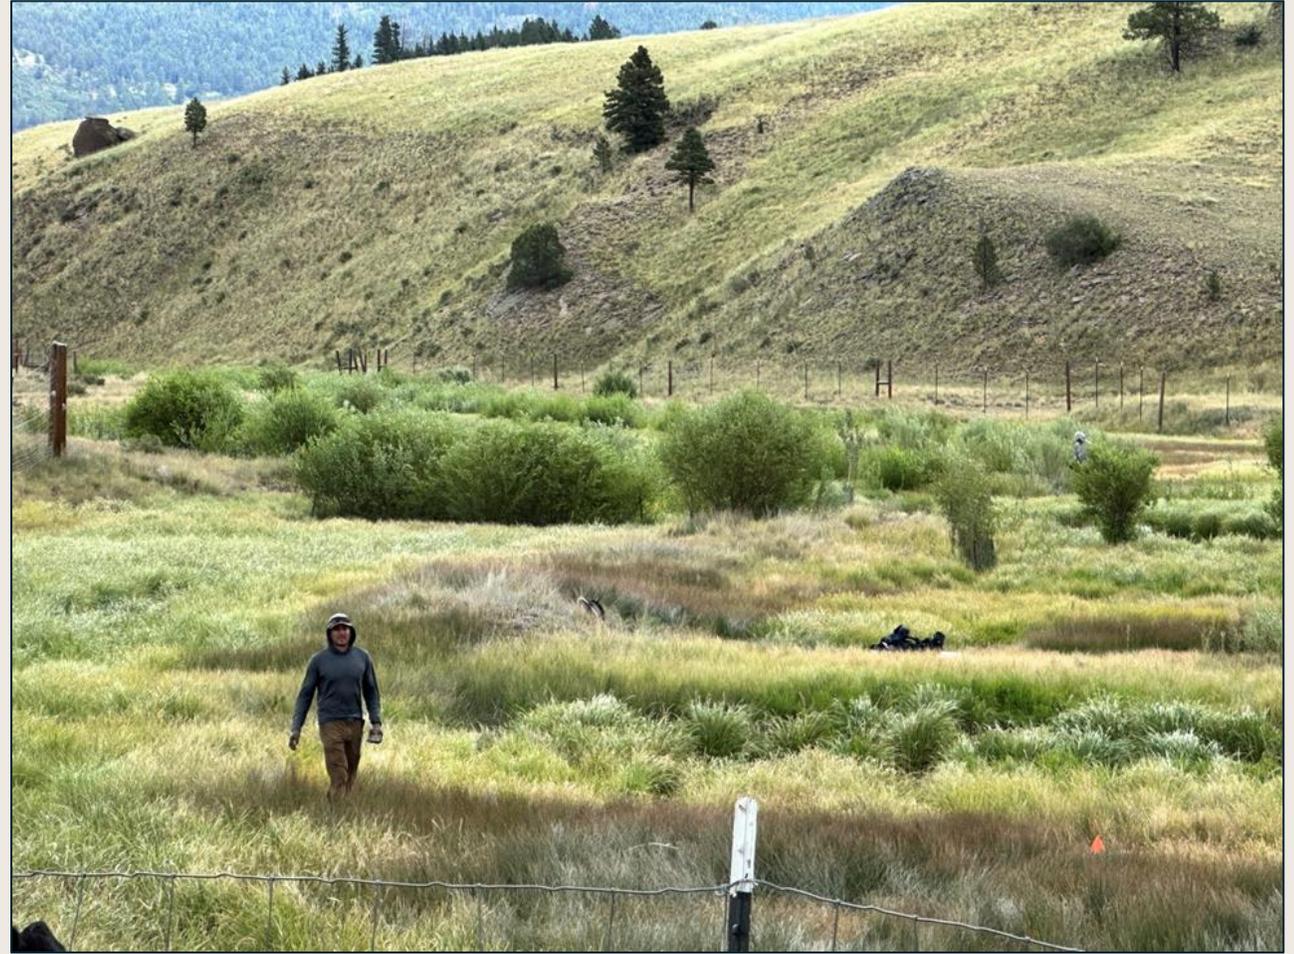
Woody Vegetation Stem Count

- Measures how many planted riparian shrubs and trees are alive
- Pin and stretch a 25' measuring tape
- Plot centers are monumented
- Count all stems within the circular plot
- Identify live vegetation species if possible
- Describe general plot characteristics (height, density)

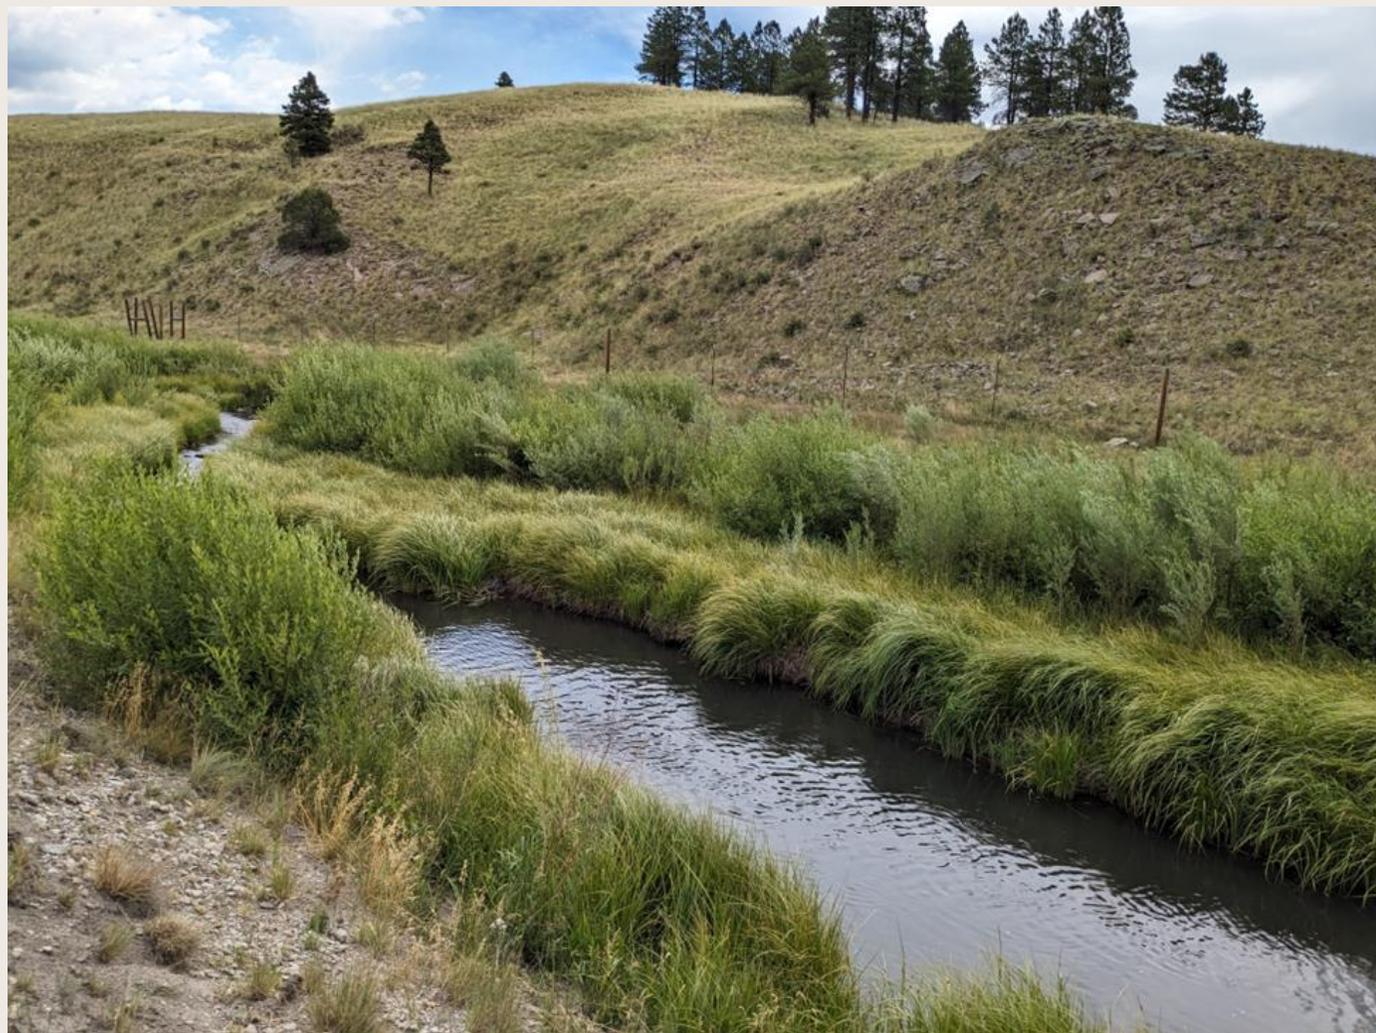
Line Point Intercept Vegetation Monitoring

- Rapid, accurate method for quantifying soil cover, including vegetation, litter, rocks and biotic crusts
- Pin and stretch a 50 meter (150 ft) measuring tape
- Locations are monumented
- 50 points per line
- Drop a pin flag every meter, record every plant species it intercepts and plant height
- Record ground surface type (e.g. bare, leaf litter)
- *Monitoring Manual for Grassland, Shrubland and Savannah Ecosystems*, Herrick et al., 2017

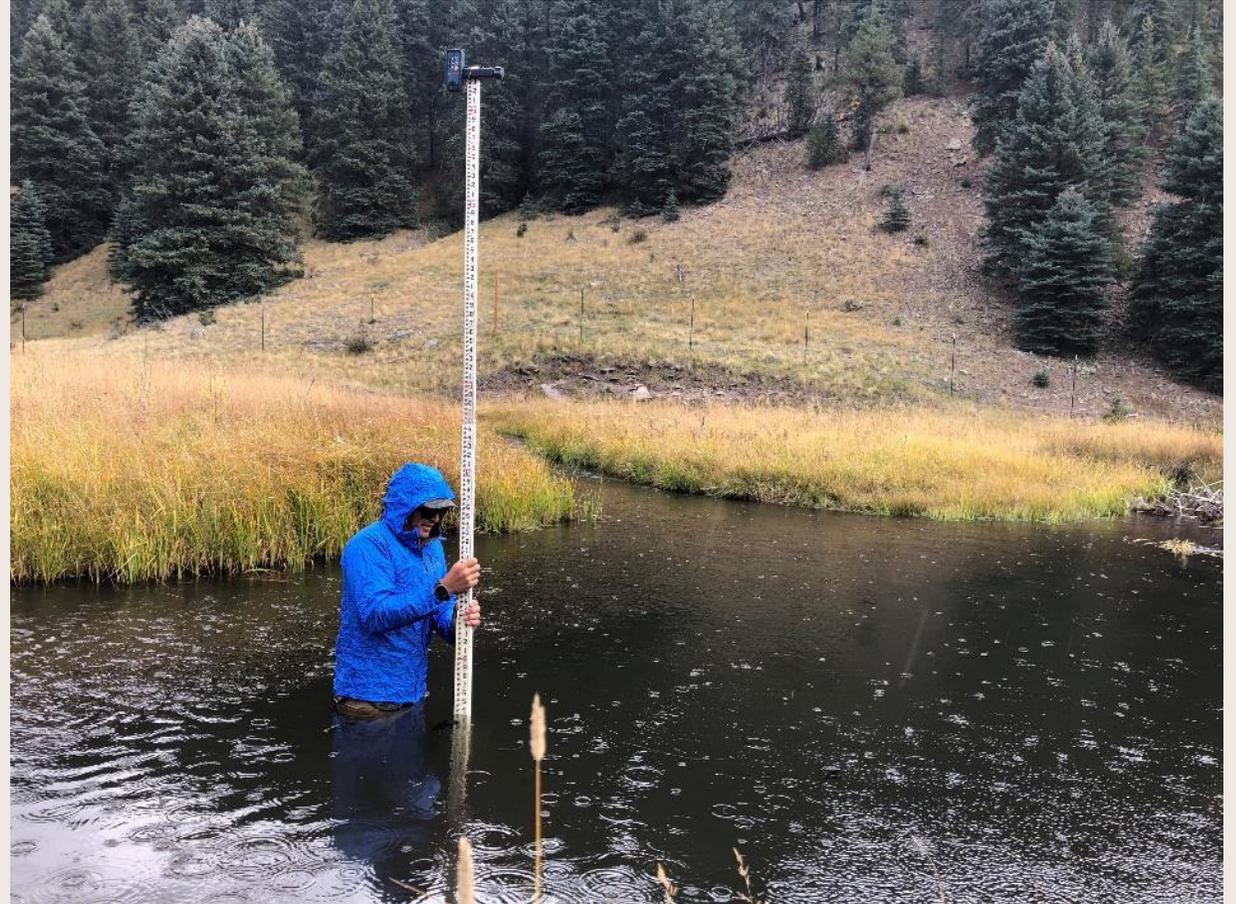
Geomorphic Monitoring

- 5 cross sections established and monumented perpendicular to the stream
- One longitudinal profile parallel to the stream
- Elevations of pertinent stream features are measured with survey equipment
- Rosgen Level 2 or Natural Channel Design monitoring

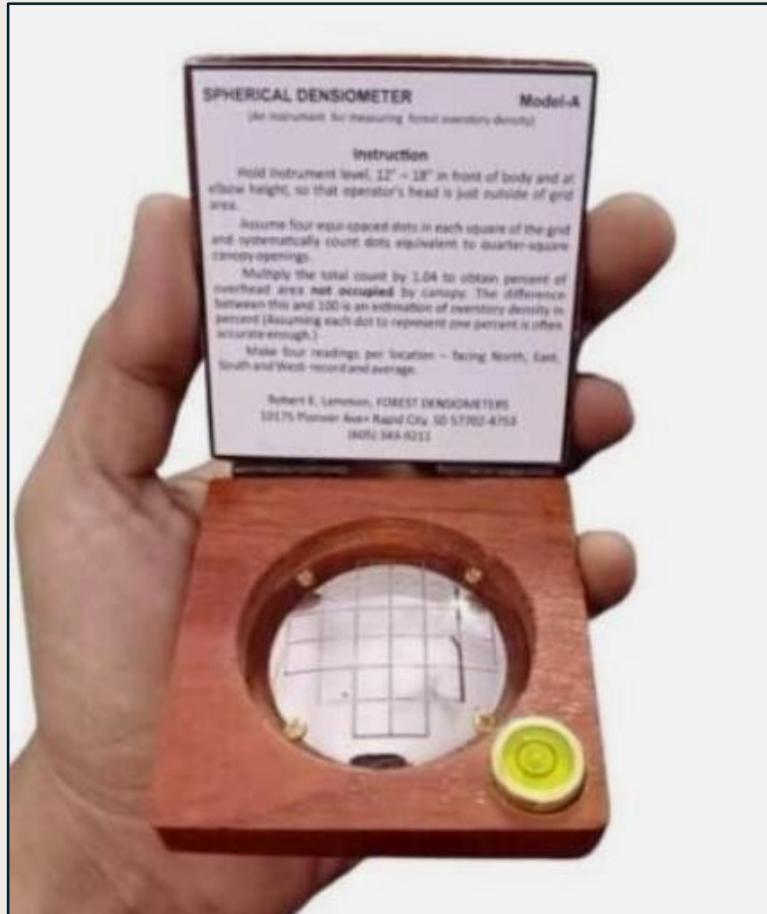
Stream Shade – Spherical Densimeter

17 line Intersections

If intersection covered by canopy = "hit".

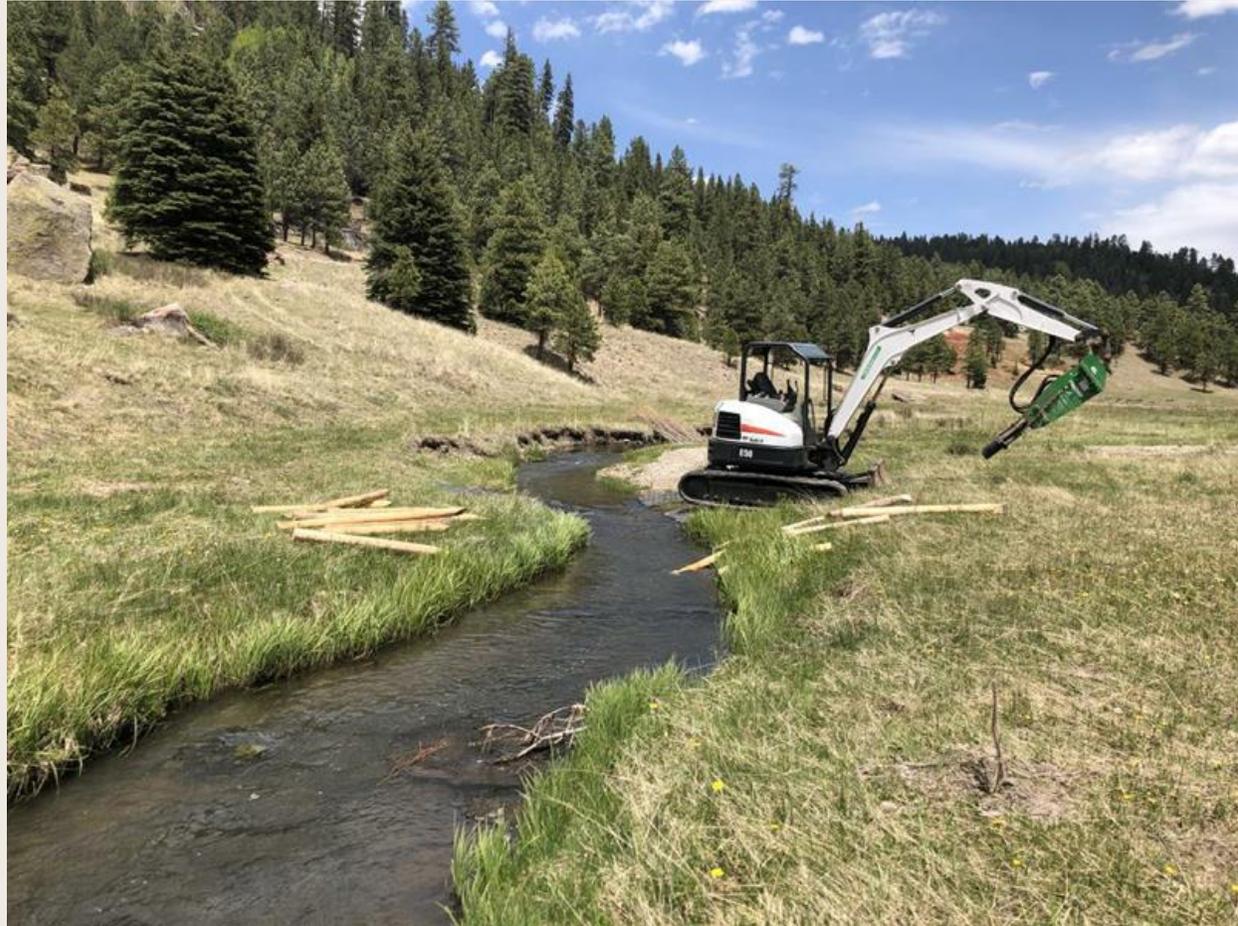
May 2020

Annual Photopoint Monitoring

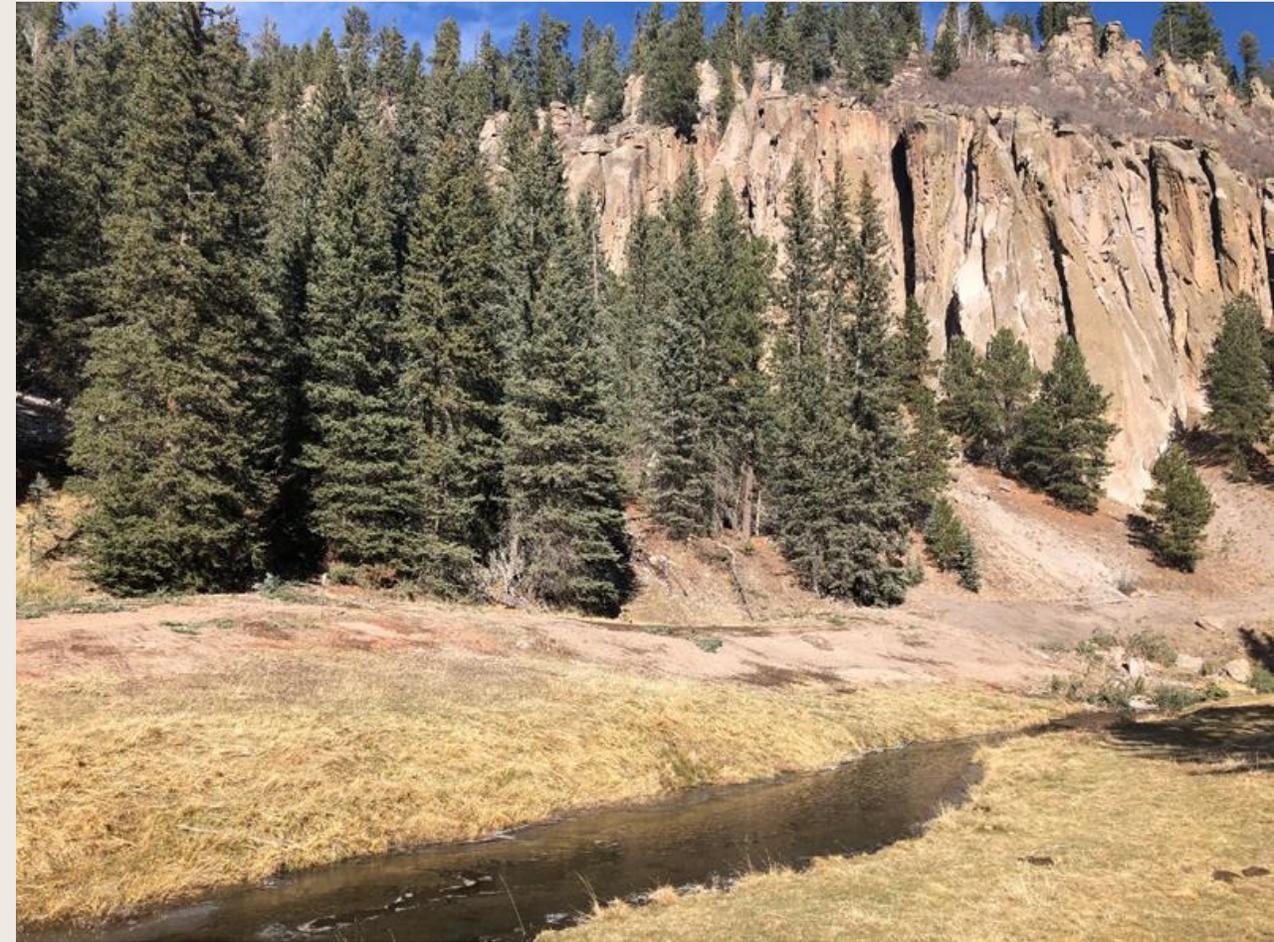
October 2020

Annual Photopoint Monitoring

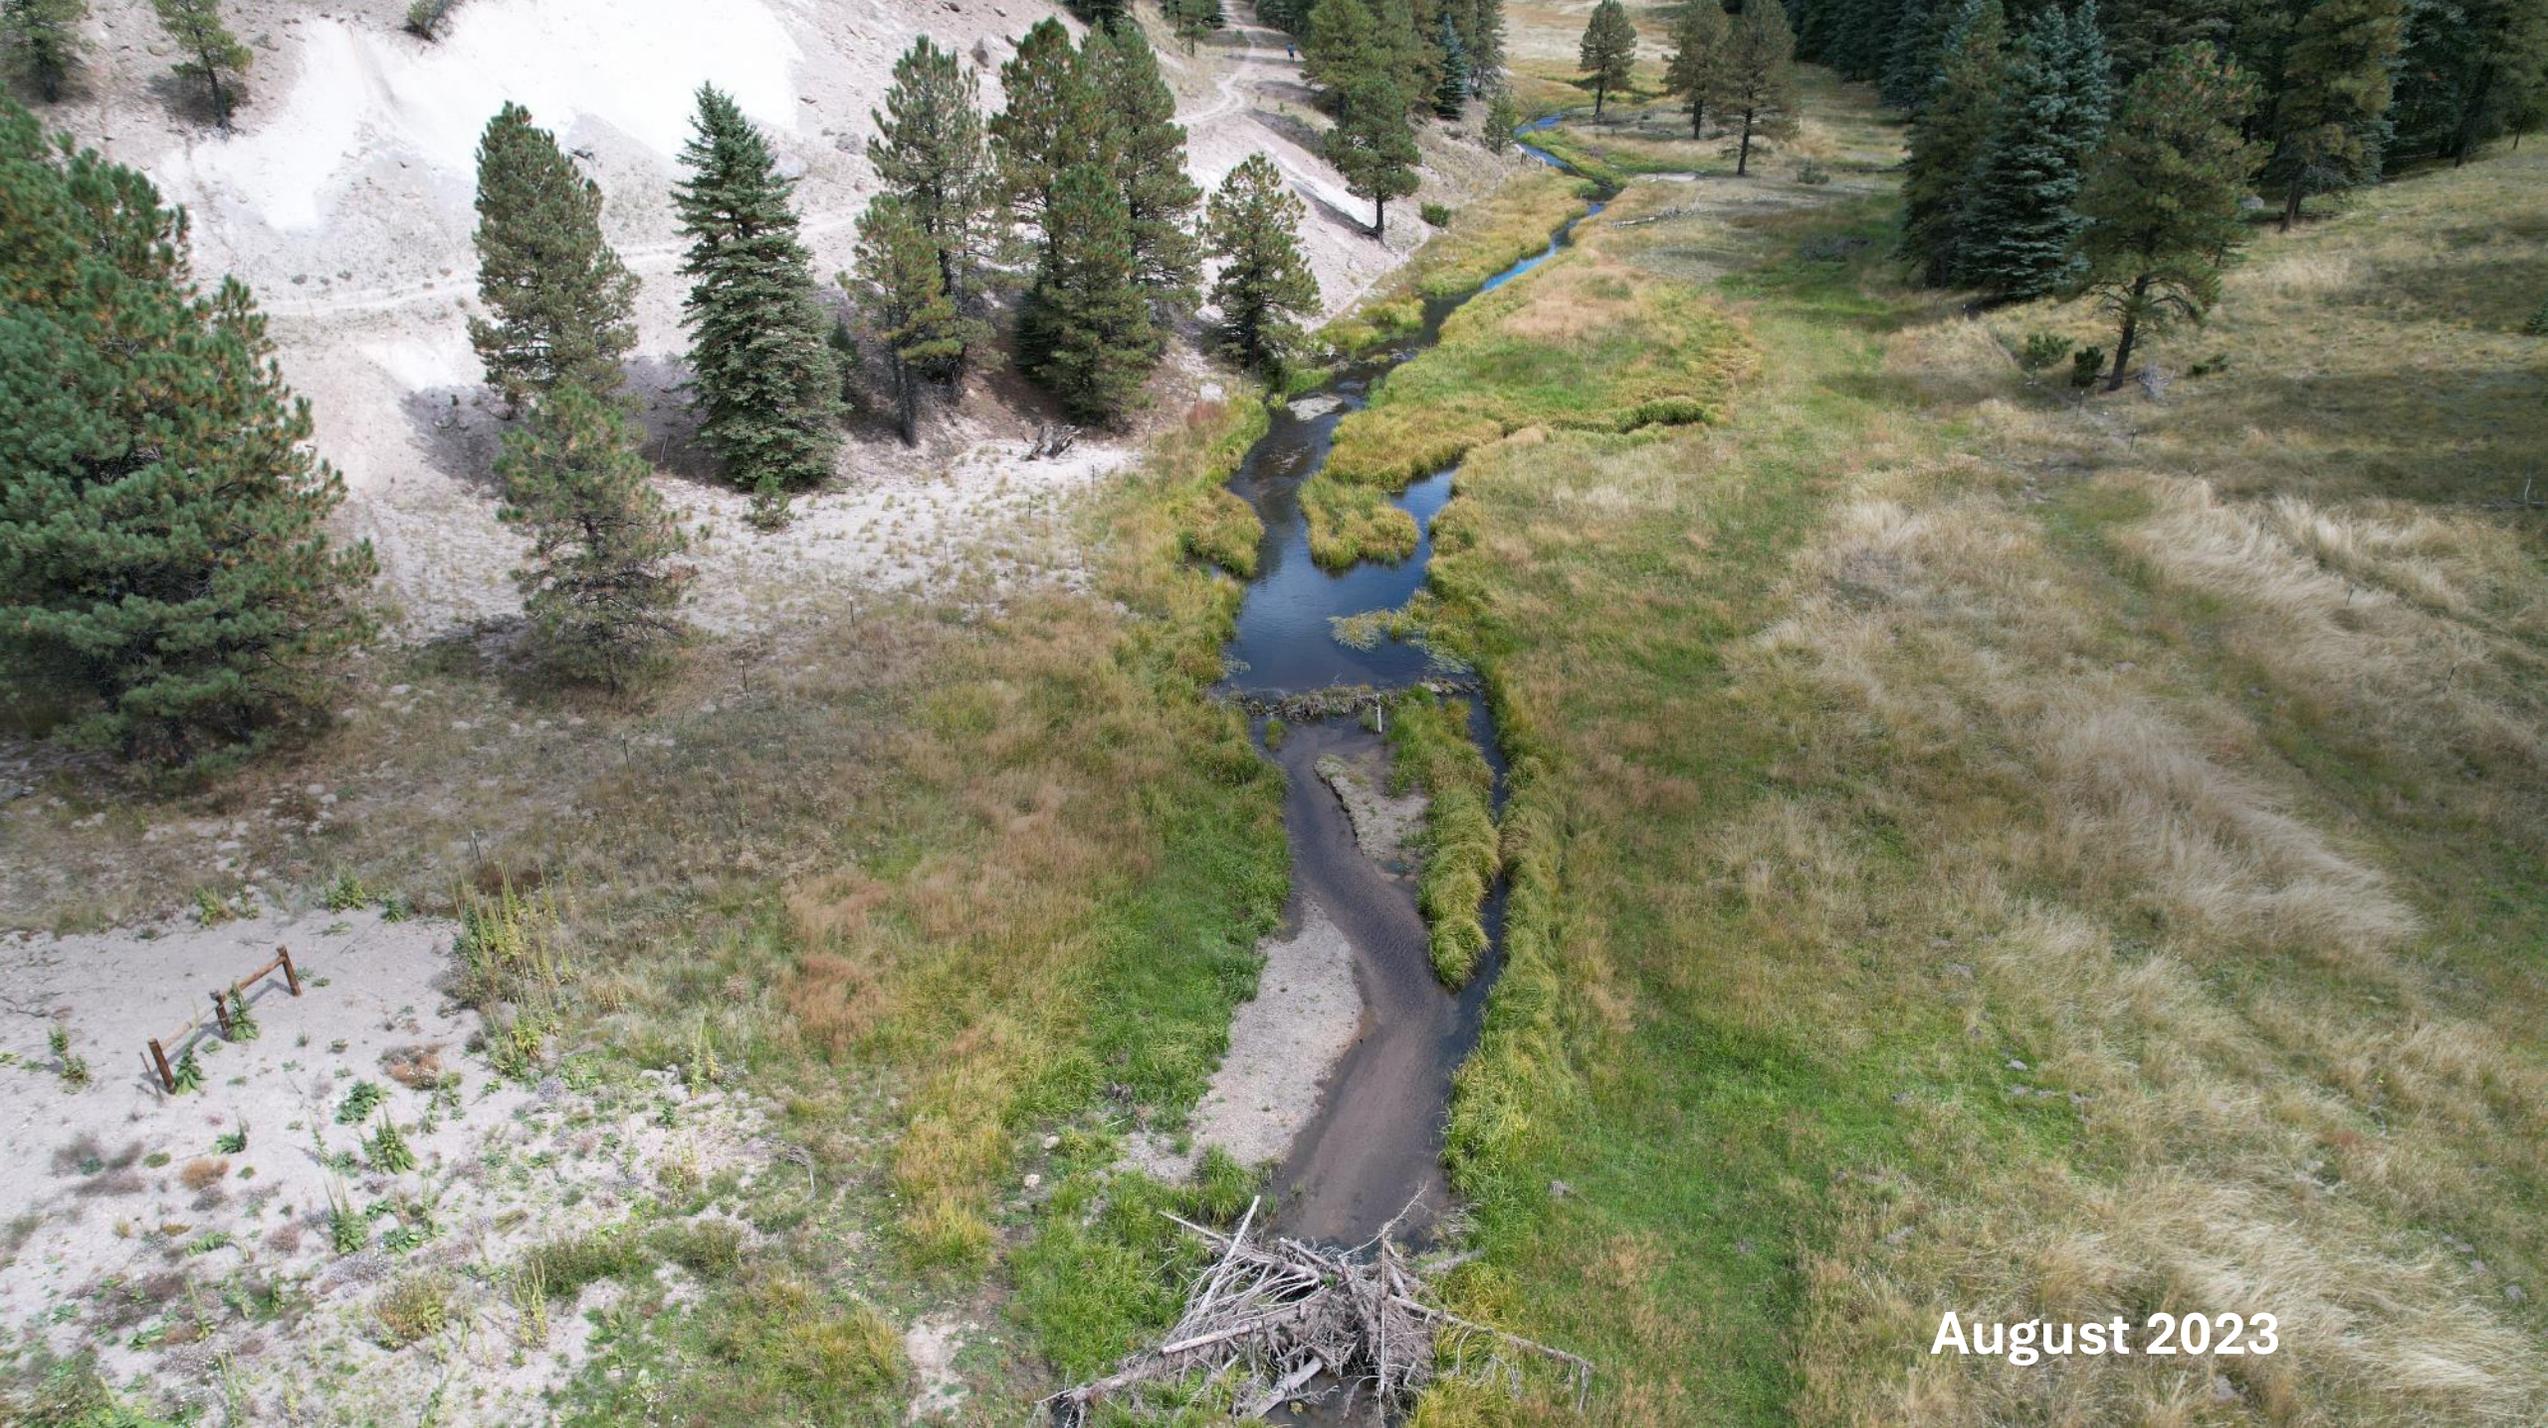
August 2023

Drone Imagery

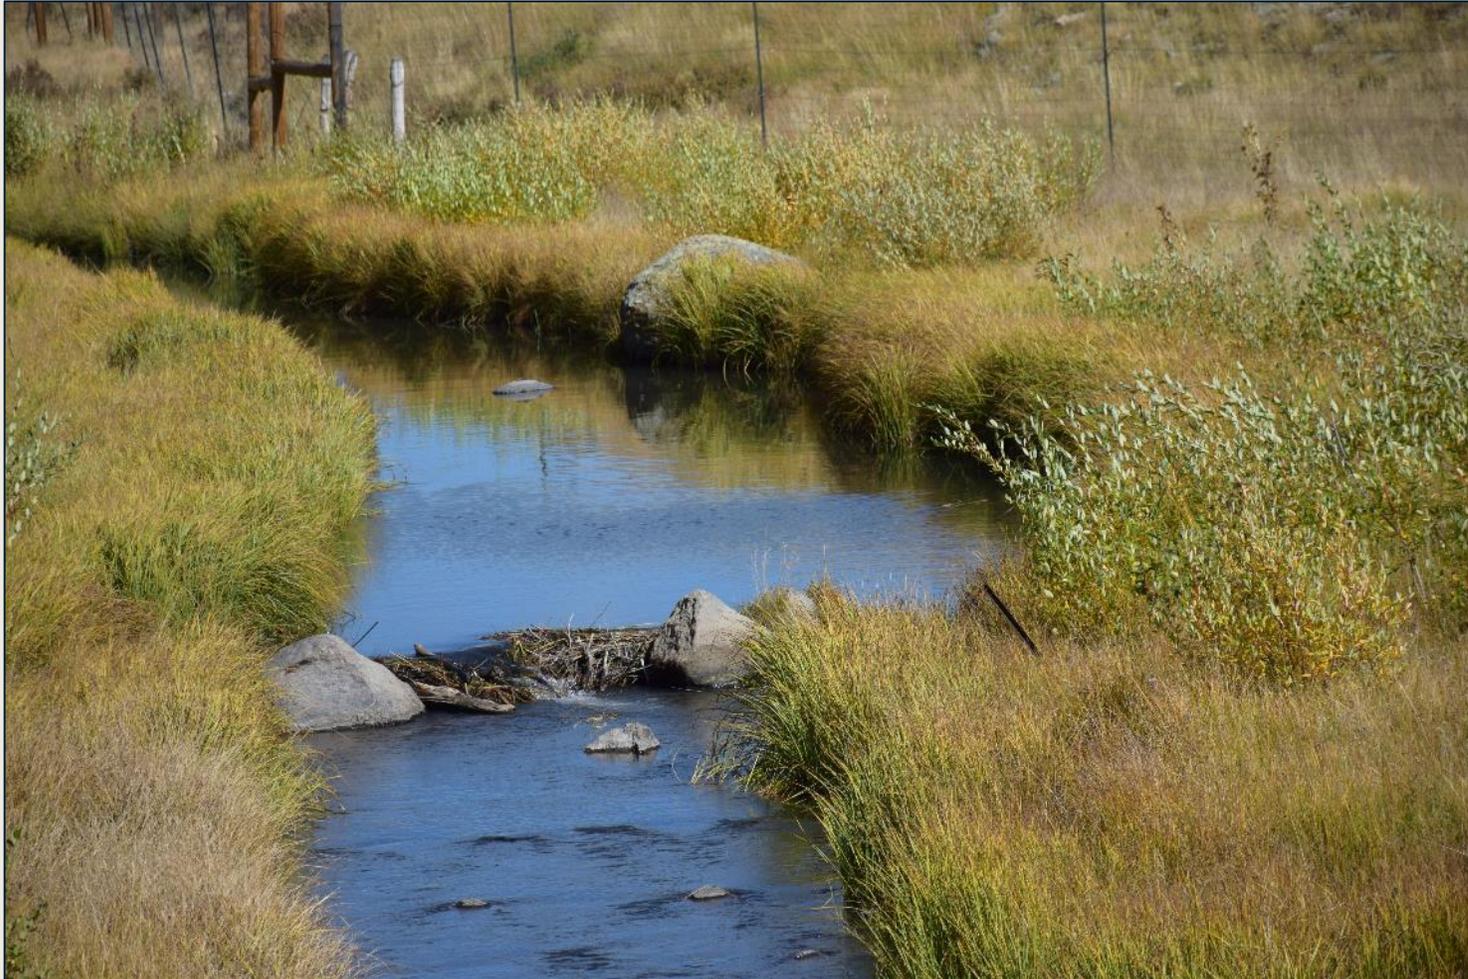
*Real beaver dam on San Antonio Creek.
Beaver occupation is the goal!*
